Goodridge Public Schools Facility Assessment

March 21, 2023

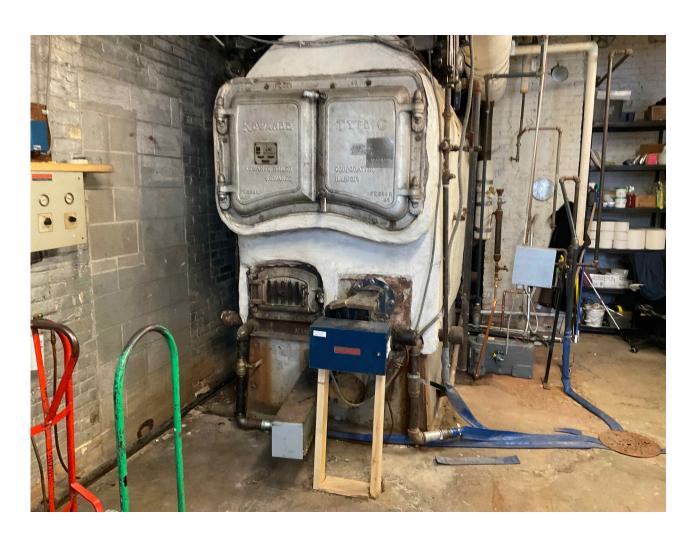
Boiler Plant

- The existing steam boiler has exceeded its life expectancy.
- There is currently not a second boiler which is recommended for redundancy if one boiler breaks down.

- Install new high efficiency hot water boilers
- Provide (2) or more boilers to provide redundancy
- Replace steam piping with new hot water piping

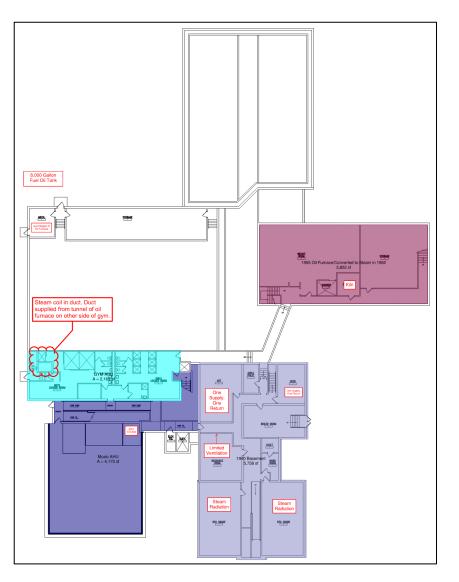
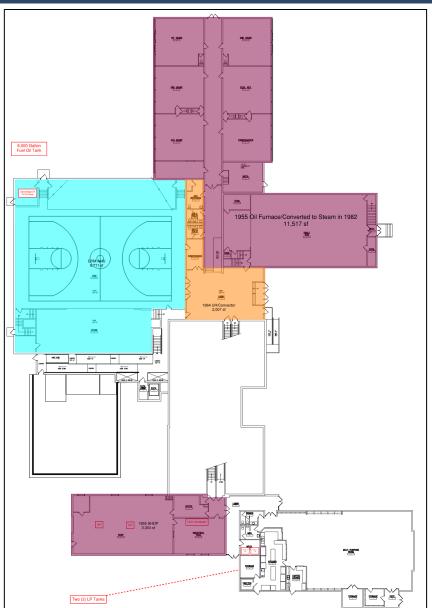
Indoor Air Quality

- The existing ventilation systems within the facility have exceeded their life expectancy.
- Most of the ventilation units are served by the steam boilers except for the gym air handling unit which uses fuel oil.
- Due to the age of the systems, they do not meet current code requirements to supply the required amount of outdoor air to the spaces.
- The facility utilizes pneumatics for temperature controls.
- There are only a few areas within the facility that provide air conditioning.

- Replace the existing ventilation systems to meet current code requirements.
- New ventilation systems will utilize hot water or gas in lieu of the current steam systems
- New units will have dehumidification (A/C)
- The replacement of the ventilation systems includes:
 - Temperature Controls (Digital)
 - Lighting (LED)
 - Ceilings (re-use the new ceiling tiles that the district has been installing).
 - Upgrading the electrical service to accommodate the additional electrical

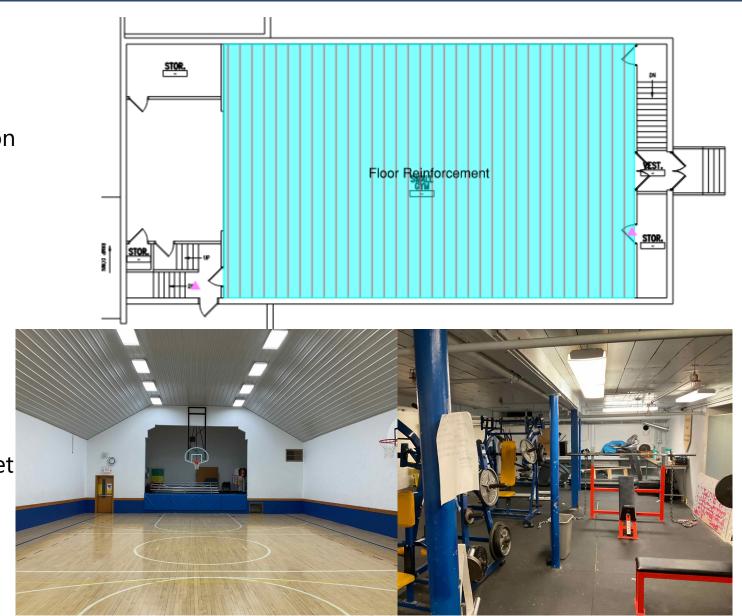
Interior Surfaces – 1936 Multi-Purpose

- The existing floor structure in the multipurpose has developed a noticeable deflection (bow) in the floor.
- There are several doors in this area that have door knobs that do not meet ADA code.

- Either replace or reinforce the existing floor structure to provide additional uses of this space.
- Replace the door hardware with levers to meet ADA code.
